Building Moisture Survey

**Steve Etzler
181 Wrenfield Way
Harleysville PA 19438**

The property at 181 Wrenfield Way Harleysville PA, 19438 was the subject of a visual, moisture meter or an infrared (IR) survey on 7/15/2014. Areas agreed and designated by the client for this survey are listed in this document.

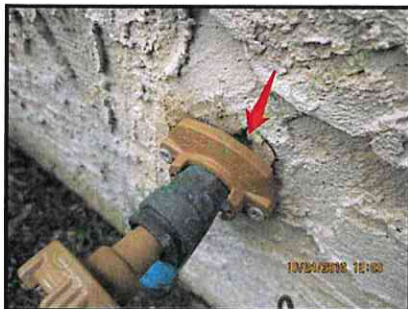
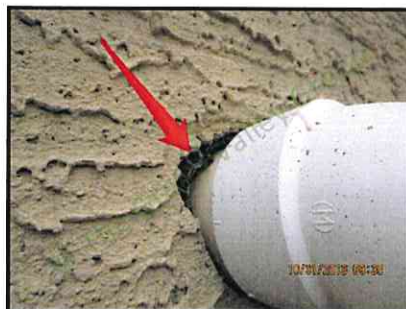
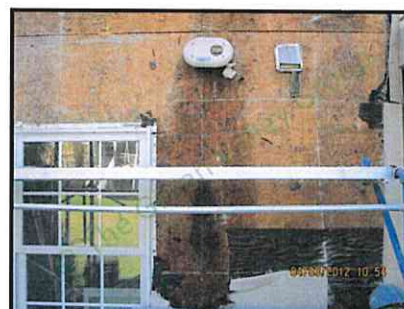
1. electrical boxes
2. exterior receptacles
3. light fixtures
4. plumbing lines and faucets
5. cable TV lines
6. satellite dish mounts
7. security systems
8. gutter straps
9. shutter brackets
10. deck rail penetrations
11. gas lines
12. dryer vents
13. telephone lines
14. damaged or punctured areas of stucco

All penetrations must be sealed with a compatible sealant as recommended by the stucco system manufacturer and required by Model Codes. Damaged areas of stucco must be properly repaired to prevent water intrusion.

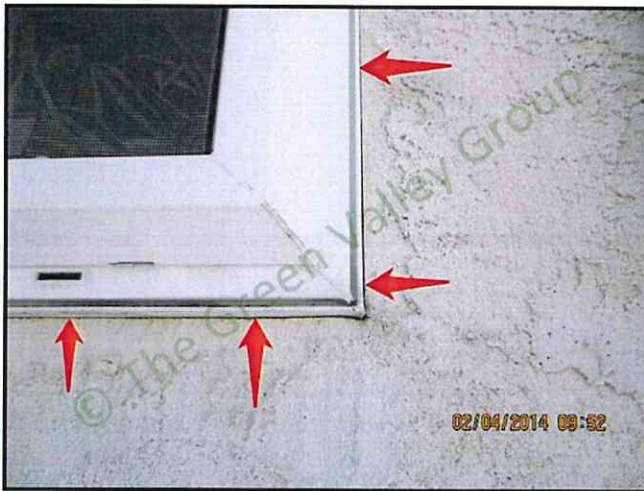
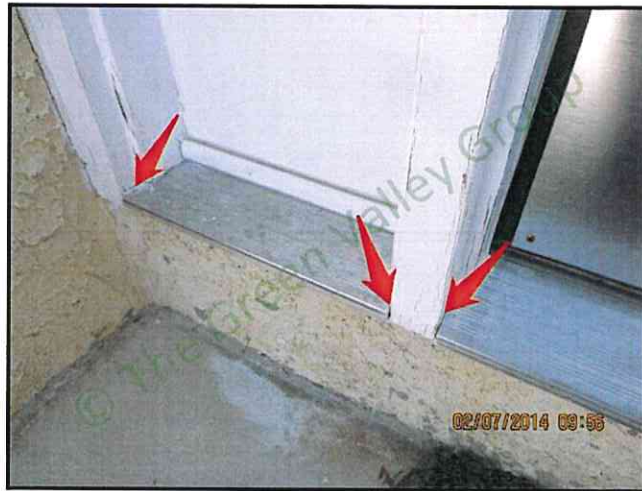
No caulking around perimeter of window or doorframes and thresholds. Stucco applicators are supposed to leave a 1/4" to 1/2" gap between the stucco and the frame to allow for a proper joint consisting of case bead, backer rod and manufacturer's recommended sealant. If no sealant is installed, a crack may eventually result, due to expansion and contraction, through which moisture or water can enter behind the stucco system. If the stucco installer did not leave the required joint and sealant, the situation will have to be reviewed to determine the best repair method. Often, the window manufacturers warranties are void unless proper detailing is installed around the window.

Improper or failed sealant joints. Some common reasons for joint failure include improper cleaning or joint preparation, lack of backer rod when needed to control joint depth, improper joint width (should be at least 3/8" to 1/2"), use of inappropriate sealant, or failure to tool the joints. Tooling the joint to a concave surface presses the caulk up against the joint sides to help ensure good adhesion and provides a consistent and neat appearance. Even if joints are properly installed, the life of the sealant is 5 to 20 years depending on the type and quality of sealant used. Sealants should be inspected annually and repairs made promptly.

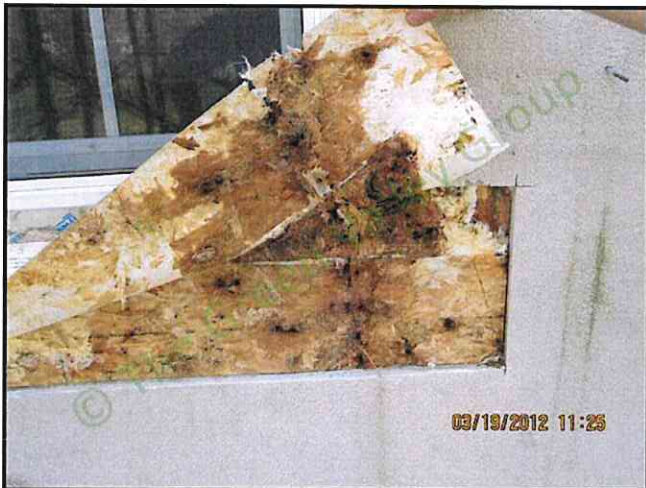
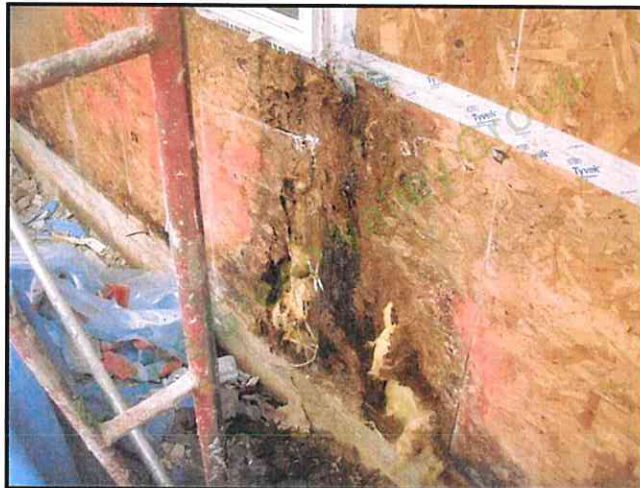
Many window and door units themselves leak through gaps in the door or window frame, sills, tracks and/or at the center mullion where two double hung windows join. This can sometimes be corrected by wet glazing (sealing the frame to glass) or by caulking the gaps in the frames or by making minor modifications to the window. If these measures are not effective, the windows or doors will have to be repaired or replaced with a higher quality window. It is said that 10% of new windows fail right out of the factory and it would be impossible to predict future failure, the most effective means of protection is to install a sill pan including a back and end dams under the window.

Doors: In areas that are prone to strong, gusting winds, in-swing doors seem to be more prone to leakage. Door thresholds should be raised a minimum of two inches and should be sealed to prevent water intrusion. Second floor doors should incorporate "pan flashing" to prevent leakage and potential damage to the areas below. Weather stripping can be used to help ensure water tightness.

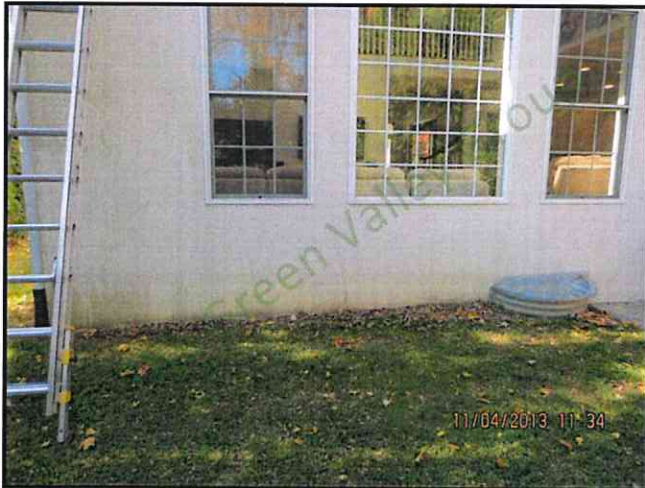
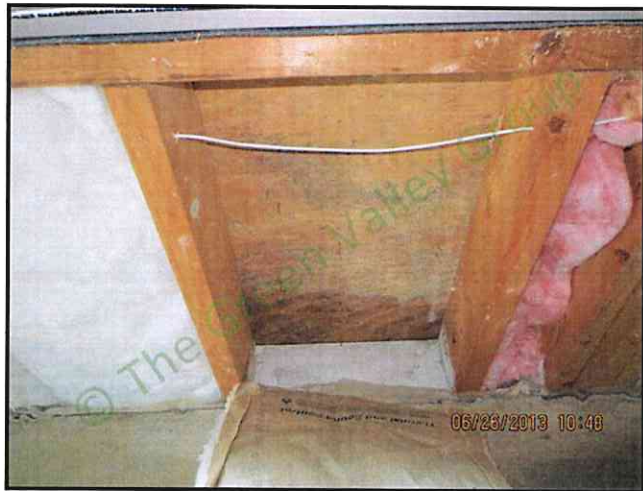
- 1) To prevent wicking and to create a clear path for drainage. Wicking is a process in which standing water is absorbed by the EPS foam board or stucco, which holds excess water in the system and prevents adequate drainage. Figure 1 shows an example of a home where the stucco system was not back wrapped and extended below grade. Water wicked up behind the stucco, causing mold, mildew and decay of the underlying sheathing. Wicking can also occur when stucco is terminated at grade level as seen in Figure 4.
- 2) To eliminate a direct path for termites through the EPS board or behind the stucco as well as establish easy access for termite inspectors. Because of the increased risk of termite infestation, many pest control companies won't issue termite warranties for buildings with below grade stucco terminations including 'hard coat' stucco systems in many cases.

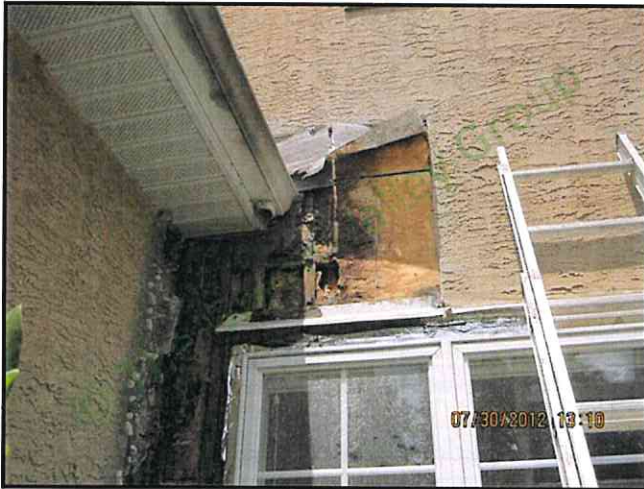
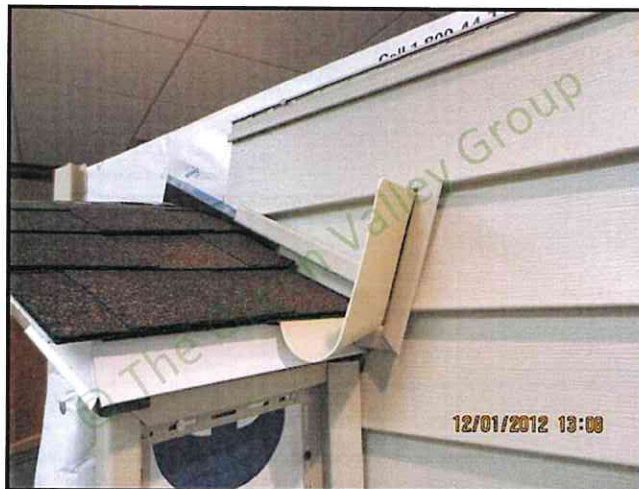
Installation of a kickout flashing in an existing stucco system involves cutting out the stucco to reveal the step flashing, inserting the kickout flashing under and behind the step flashing. New stucco base, mesh and finish coat is then applied to blend in with the adjacent stucco as closely as possible. If stucco color cannot be closely matched, it may be necessary to coat the area to a corner if possible.

Other Roof Flashing: Since many stucco homes have complex roofing designs, other critical flashing areas may also be improperly detailed. Any roofline that terminates into stucco may pose a problem.

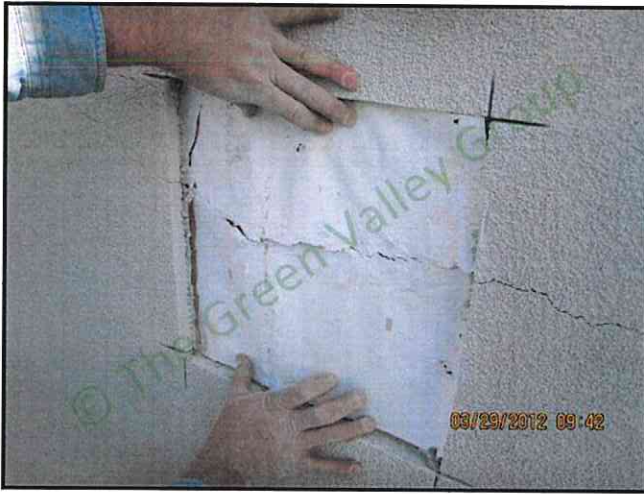
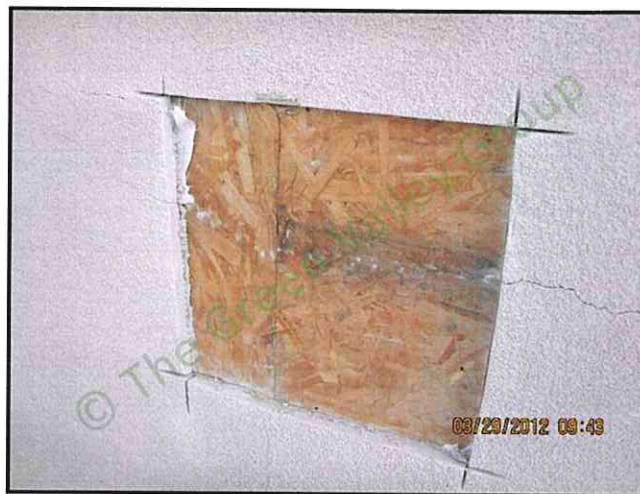
Water Intrusion Problems Related to Cracks and Breaches in the Stucco

It does not take a very big crack to allow water intrusion. In fact, a crack as small as 1/16" of an inch wide can permit bulk water to enter behind the stucco. All cracks 1/16" wide or larger and all damaged areas of stucco should be properly repaired as per manufacturers guidelines. Many times the patched areas will still be slightly noticeable even with a good repair application. Extreme cracking will sometimes require the removal and reapplication of the stucco and finish to prevent more cracking and provide a consistent appearance. Cracking is common in hard coat stucco systems, therefore control joints are called for every 144 sf, as well as between floor lines. Control joints are needed between floor lines to compensate for the cross-grain shrinkage of wood. The lack of a control joint between floor lines may result in a compression crack in this area. Again, consult with manufacturer for specific requirements of control joints. The most common areas that experience cracking in stucco are at the corners of windows or roof terminations.

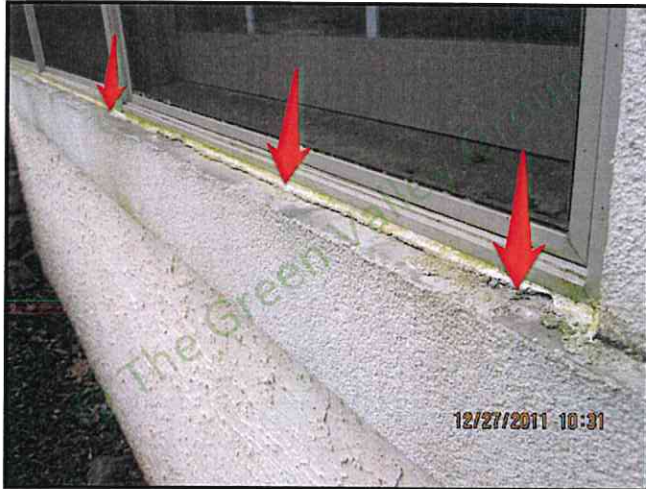
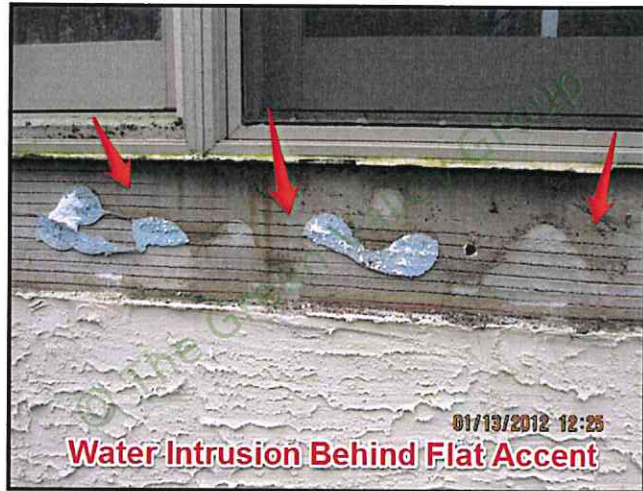
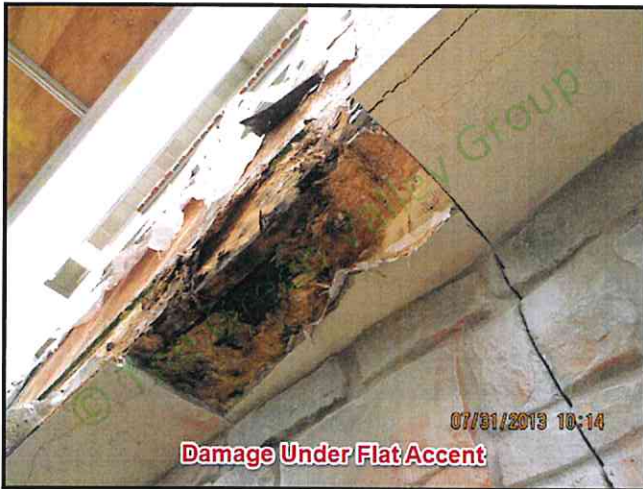
Water Intrusion Problems Related to Stucco Accents and Flat Stucco Surfaces

Flat stucco surfaces, whether conventional hard coat stucco or EIFS, collect and hold water in its rough texture, softening the finish coat, damaging the system and promoting leaks, mildew and discoloration. A good design will call for bands, quoins, and other accents to have a slope to prevent water accumulation.

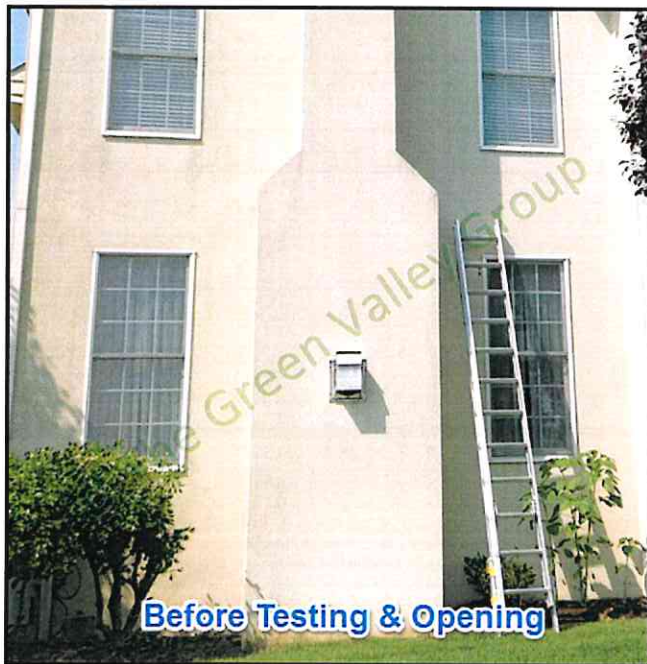
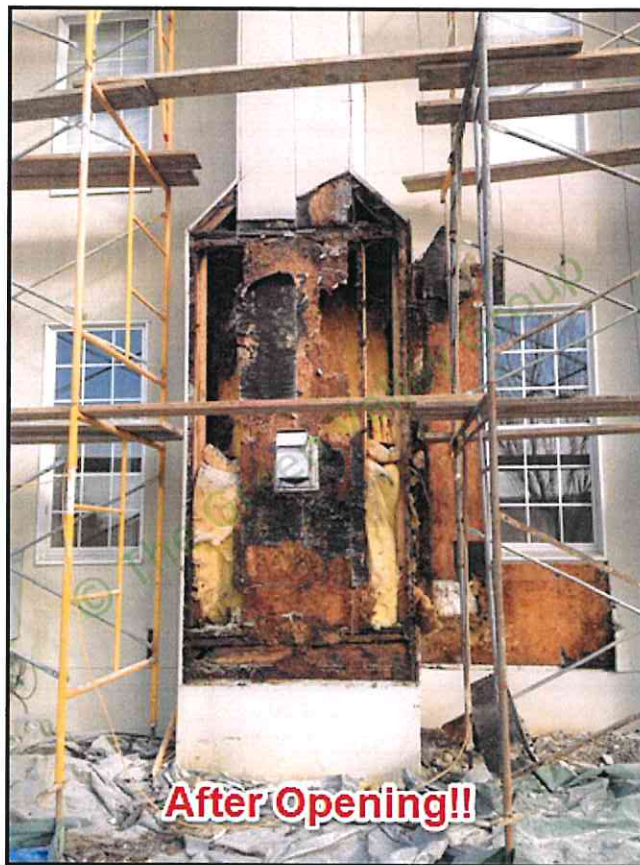
No matter whether the exterior cladding is brick, stucco, or vinyl siding, chimneys are a prime area for water intrusion since 1) they intersect with the large volume of water running down the roof surface 2) Stucco is not a roofing material and should not be used as such on the chimney hips unless proper roofing materials and underlayments are utilized during construction and 3) They're subjected to extreme expansion and contraction due to the hot and cold temperature fluctuations when the chimney is used during the winter. This extreme expansion and contraction can fatigue the sealant joints around the chimney and cause cracks or gaps to form around the edge of the stucco where the stucco terminates into the chimney structure, allowing water to enter. Therefore, water diversion through the use of flashing and proper chimney caps with sufficient overhang are very important.

A properly designed chimney cap will help shed water out and away from the top of the chimney in order to help prevent leaks in this area.

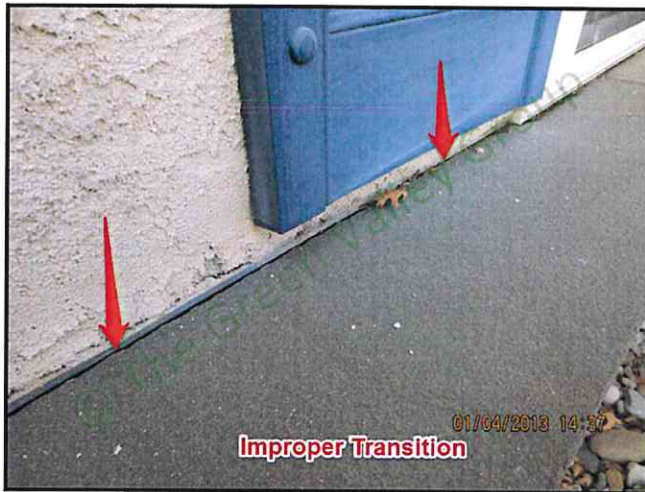
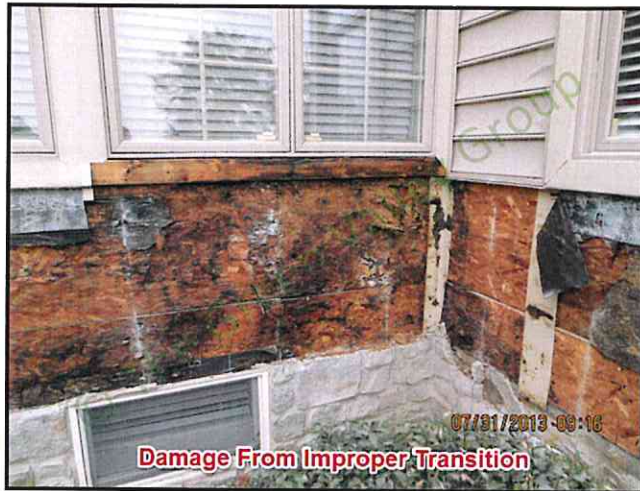
Different materials expand and contract at different rates. This expansion and contraction causes a crack or gap to form where the two materials join.

If left un-flashed, unsealed or if sealed improperly, this area will allow water to enter the wall cavity. Examples of this would include stucco to wood trim, stucco to brick, stucco to stone, stucco to concrete, etc. All areas such as these should be properly flashed and sealed with quality sealants and appropriate bond breakers.
